BOILER EXPLOSION DURING COMMISSIONING PHASE

Date Of Incident: DEC-2000

Location : WSHAC

Case Study-002

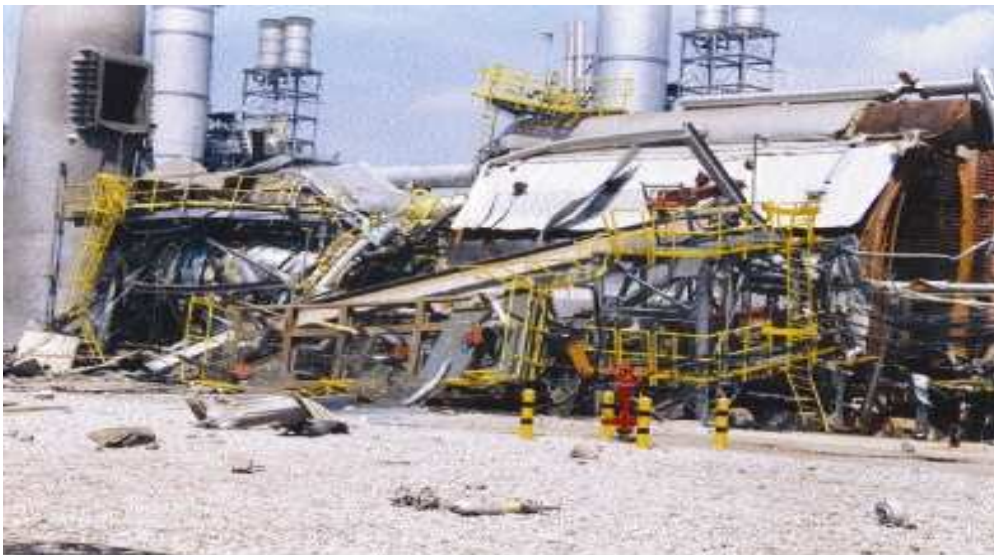
Photograph:

Boiler was on LPG firing.
Night order was given to light up diesel burner in boiler.
Personal attempted to light up the diesel burner at about 12:30 am. They made several attempts but were unsuccessful. Suddenly boiler exploded with loud noise.

Immediate cause: Use of unauthorized bypass method.

Site investigations after the accident confirmed that the 2 bypass valves were 50% open. This confirmed that the bypass method was utilized to restart the boiler. Data records confirmed that the LPG control valve was about 66% open just before the explosion. The block valves before and after the control valve were fully open. A direct path was therefore established to allow LPG to enter the firebox, resulting in the explosion of the boiler.

Ensure strict compliance to safe work procedures. Strict enforce permit to work system.

Conduct competency training for all personnel. Review and improve OSH management system.
