## **FORKLIFT INCIDENT**

**Date Of Incident: JULY 2006**

**Location : ARKTOS**

**Case Study 007**

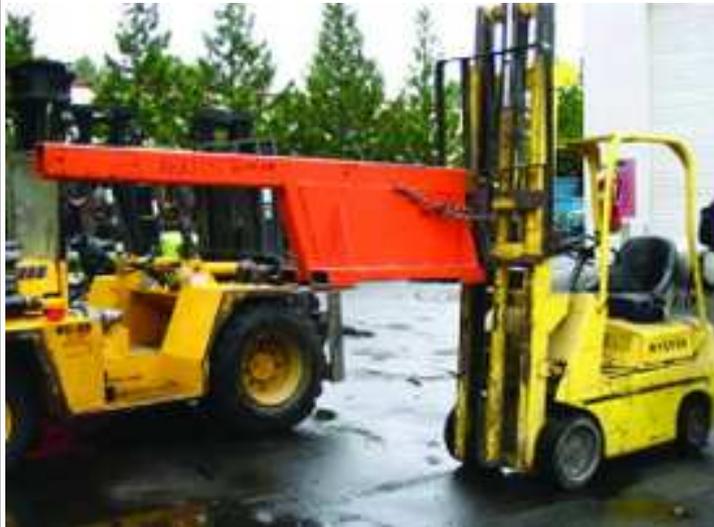
**Photo graph:**

Worker 2 aligned the jet pump with the base and asked Worker 1 to lower the pump the remaining inch onto the base. Worker 1 looked around to see if there was another worker in the area who could operate the forklift and lower the pump, but he was unable to get anybody's attention. Worker 1 walked under the fork extension, bent over the hull, and reached for the forklift controls through the forklift carriage. The carriage and fork extension suddenly dropped onto Worker 1, trapping him under the fork extension. Worker 2 and other workers used a second forklift to free Worker 1. Worker 1 was transferred to the hospital, where he died of his injuries.

Before the incident there was no information available to the workers on the lifting capacity of the forklift when used with the fork extension. A WorkSafeBC professional engineer examined the forklift and certified that its working load limit (WLL) when used with this fork extension was 776 pounds at 91 inches load centre. At the time of the incident, the load on the forklift at 91 inches centre was approximately 510 pounds (the weight of the jet pump plus the weight of the web sling). This is within the certified WLL of 776 pounds and was not found to be a factor in the incident. **Lack of maintenance of the forklift.**

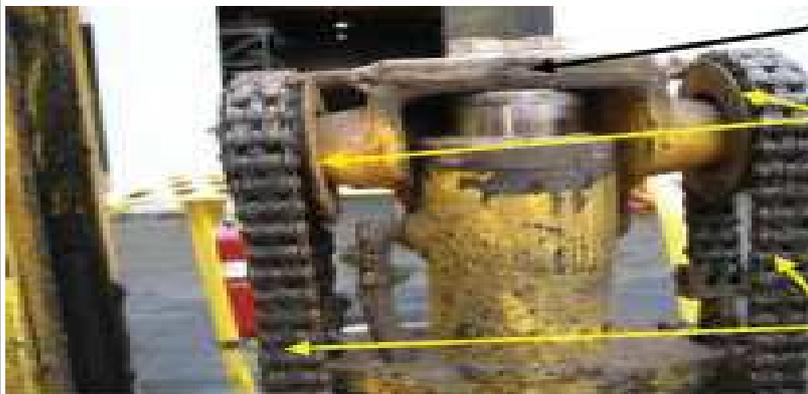
#### Photo graph:

Any grapples or forks on mobile equipment must be landed in a safe position before the equipment controls are left unattended.

If a worker is required to work beneath an elevated part of mobile equipment, the elevated part must be securely blocked.

Worker 1 had not been trained by a qualified instructor or supervisor to be a qualified forklift operator and he may not have been aware of these requirements. A trained and qualified forklift operator would have received this information as part of the operator training.

The employer was ordered to ensure the health and safety of its workers, including but not limited to the following, without delay:

Ensure that forklift operators are adequately trained and qualified by a qualified supervisor or instructor.

Ensure that all the tools, machines, and equipment are capable of safely performing the functions for which they are used.

Provide its workers with adequate instruction, training, and supervision as necessary to ensure health and safety of those workers in carrying out their work duties.
