FATAL CRANE INCIDENT

Date Of Incident: 22.10.2007

Location : Brazil

Case Study 001

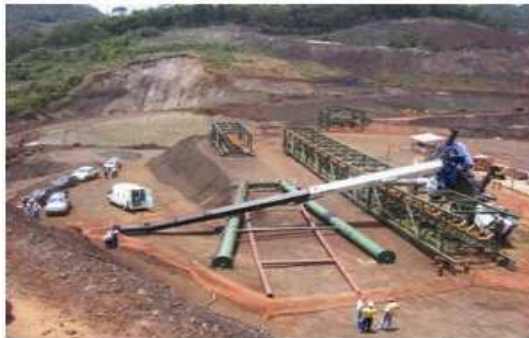
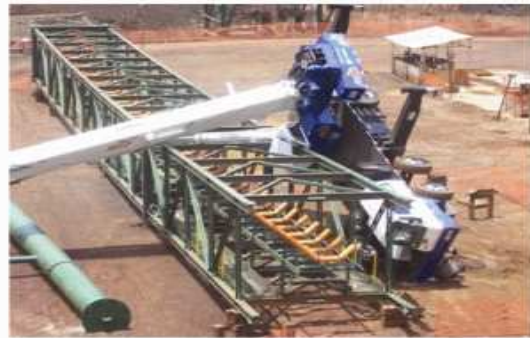
Photograph:

During the construction activity of lifting and moving the steel structure that supports the conveyor at the Alegria 8/9 stockpile to a new location, the crane lost stability, rolled over onto its sides coming to a stop against a section of a conveyor gallery that was being pre assembled adjacent to the crane location due to the roll over, the crane cabin with the operator onboard, was crushed against the conveyor gallery structure pinning the operator in his cabin and causing fatal injuries.

The crane was out of radius for its set up and the weight of the load.

There was no rigging plan in place for the lift.

Wrong crane used for the lifting task.

The crane operator had a history of overriding the crane limits and overloading the crane shown by computer records from the crane over 40 overloading incidents during October 2007;

1. The computers in all site cranes (where fitted) have their data downloaded to investigate if the overloading of cranes is a general violation restricted to this crane operator.
2. Emergency bypass controls are to be locked in the off position at all times.
3. Crane operational data from the onboard computer is to be downloaded each month to review the safe use and operation of the crane for the month.
